# Ice Engineering

U.S. Army Cold Regions Research and Engineering Laboratory, Hanover, New Hampshire

# Performance Survey of Inflatable Dams in Ice-Affected Waters

Number 30 October 2001

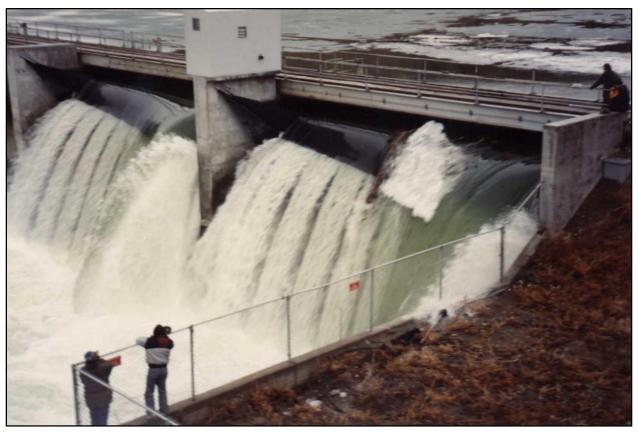
Some of the air bags leak in the crease areas near the concrete bulkheads. Also, leaks in the upstream and downstream faces of one airbag resulting from a high-powered rifle round were mended using a tubeless tire repair kit. Brian Carroll, who has been at the project since the installation of the inflatable dam, is very pleased with its performance.

Figure 2. Ice and debris passing over Broadwater Dam on the Missouri River at Townsend, Montana. Note the vee notch in the airbag near the land-side bulkhead.

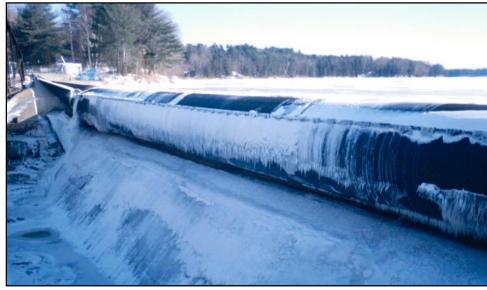
A 4.6-m-high by 67-m-long (15-ft by 220-ft) Bridgestone inflatable dam regulates pool elevation at a 9.8-MW hydroelectric plant owned by the village of Swanton, Vermont, on the Missisquoi River at Highgate Falls. Figure 3 shows the dam in its fully inflated configuration. Plant Manager Alan Mosher describes the new dam as a godsend in terms of reducing ice problems.

Figure 3. Highgate Falls Dam, fully inflated, 21 January 2000.
